# INSPECTION REPORT

**91-1143 KANELA STREET, M7**  
EWA BEACH, HI 96706

Prepared for: SOPHIA THOMPSON  
Inspection Date: Monday, July 29, 2024  
Prepared by: Steven Fierros

RE: Report No. 1118  
91-1143 Kanela Street, M7  
Ewa Beach, HI  
96706

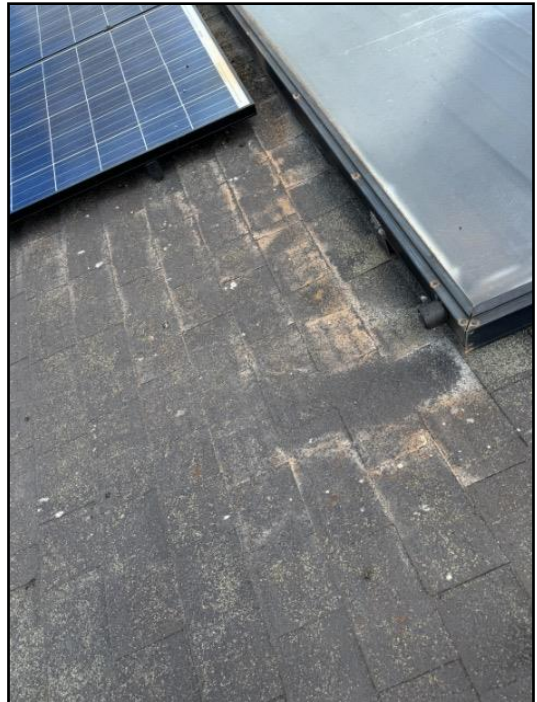
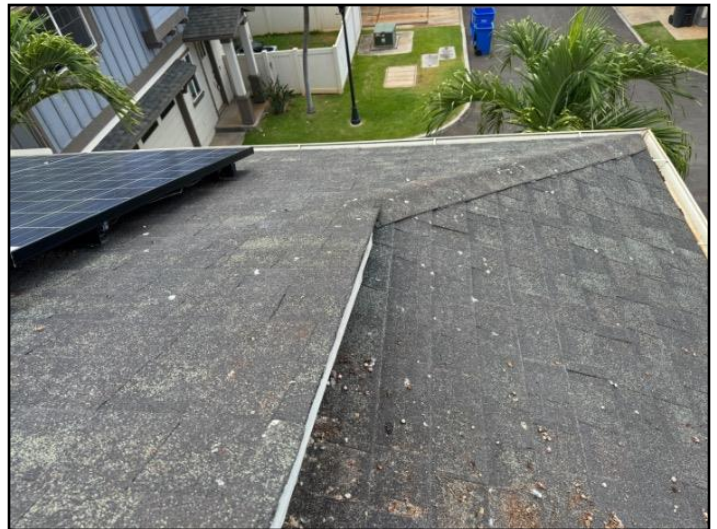
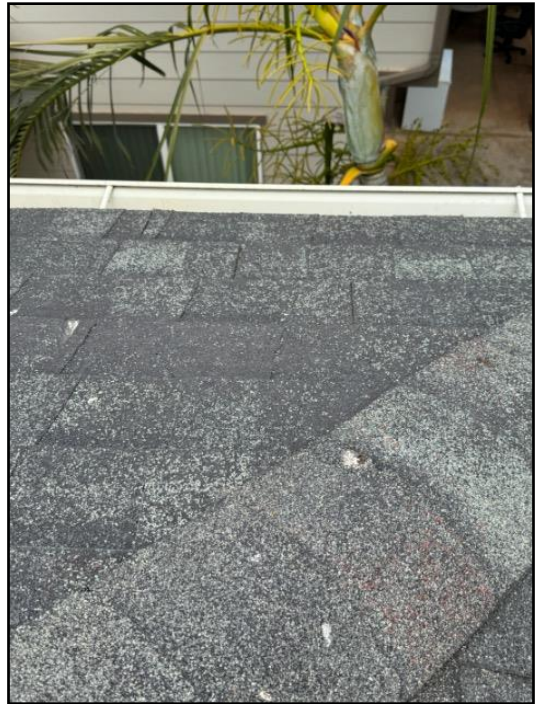
Heavy granule loss was observed at street facing roof plane. Various birds and bird presence was observed at this area and below PV panels. Recommend further evaluation and repair/replacement by a qualified roofing contractor. Would also recommend protection of under panels to prevent future pest presence/issues.

*Granule loss*

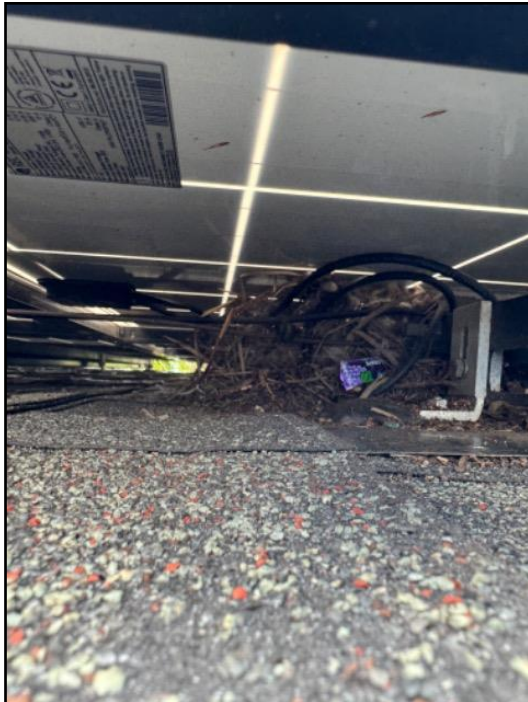
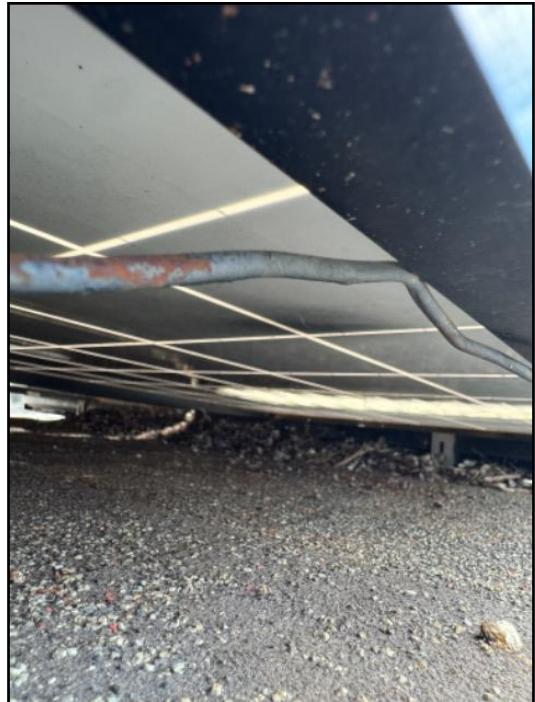
- Condition:** • Pest presence
- Implication(s):** Active pest presence(birds) was observed on roof and under PV panels. Recommend cleaning/improving.
- Task:** Clean Protect

*Pest presence*

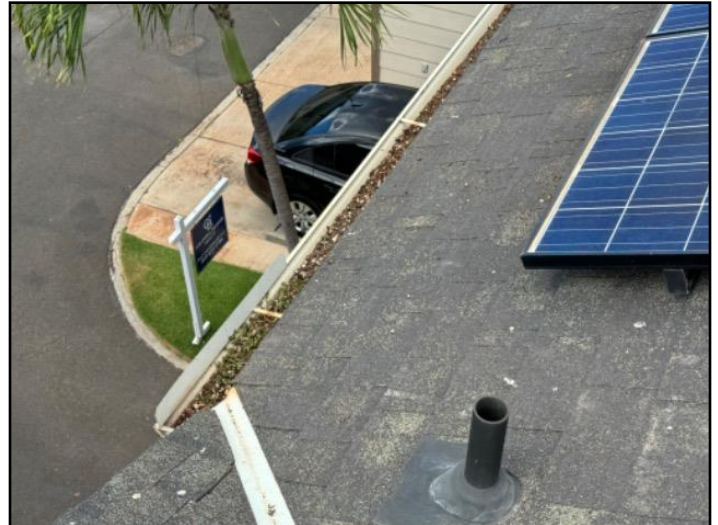
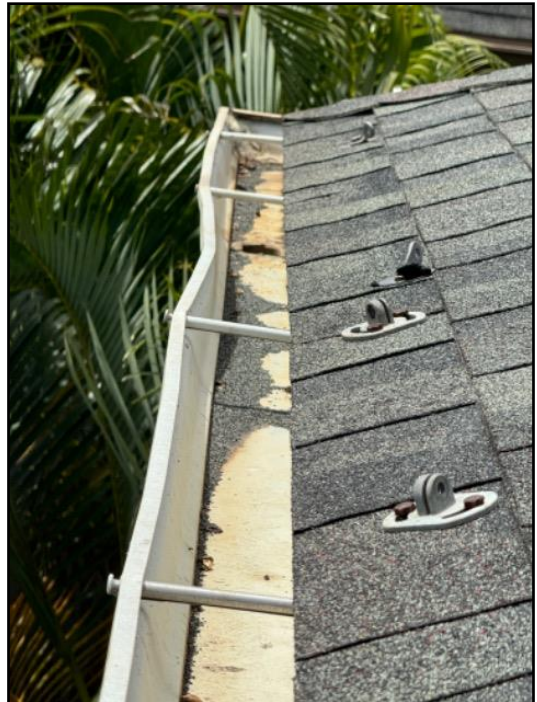
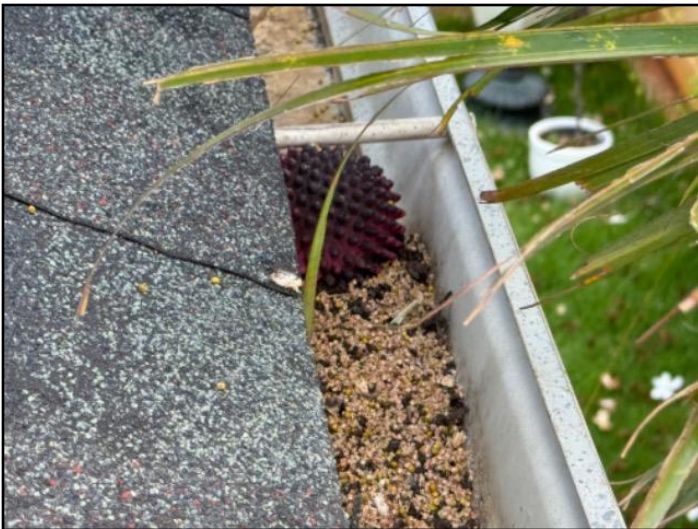
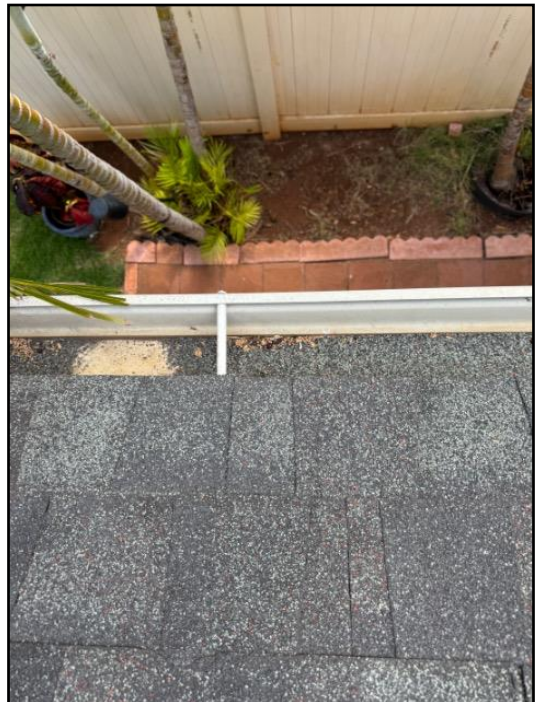
Would recommend cleaning gutters routinely to avoid poor drainage and ponding. Debris and rock loss was observed. Recommend cleaning.

*Dirty/debris*

*Damage/rock loss*

*Rock loss*

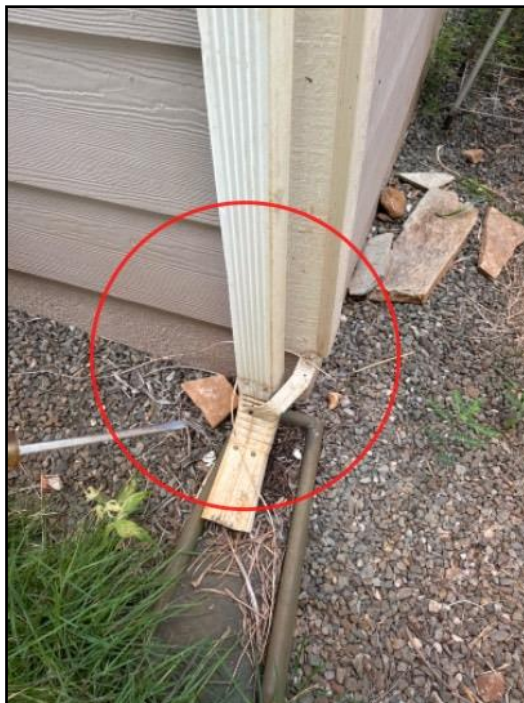
Gutter downspout at rear left corner of home was loose. Recommend repair/improvement to avoid poor drainage/damage.

*Connections loose*

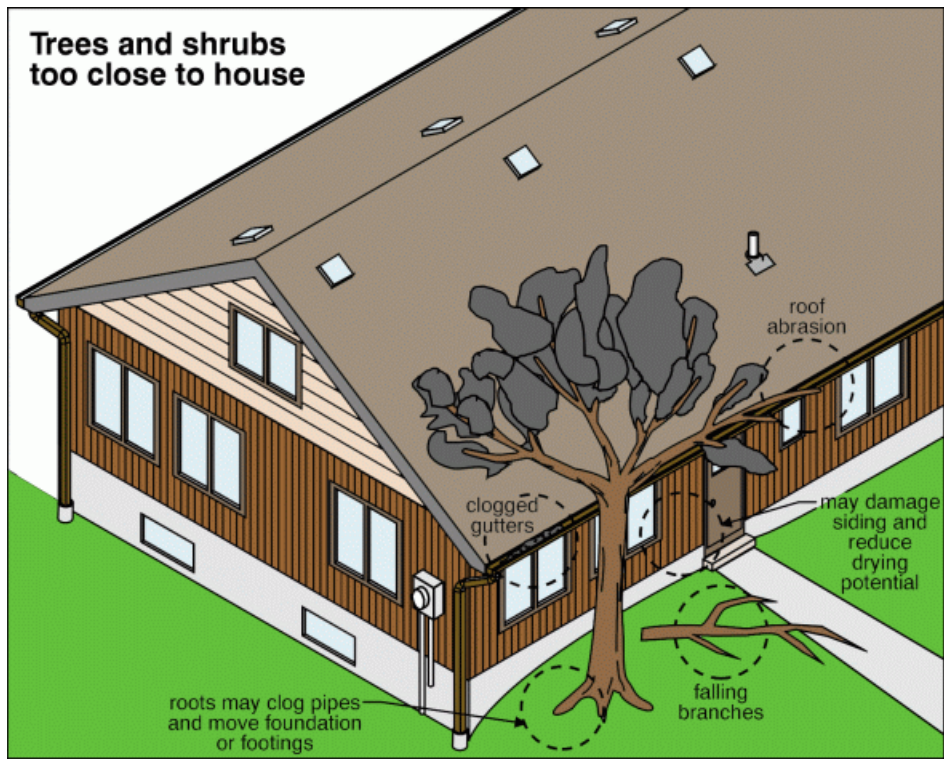
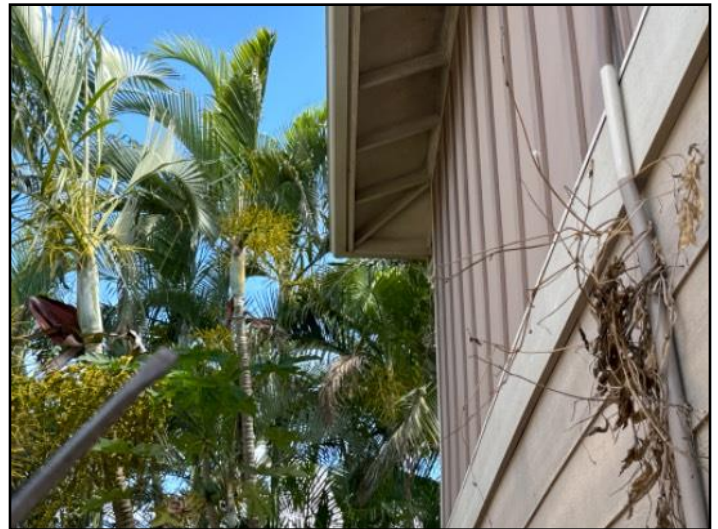
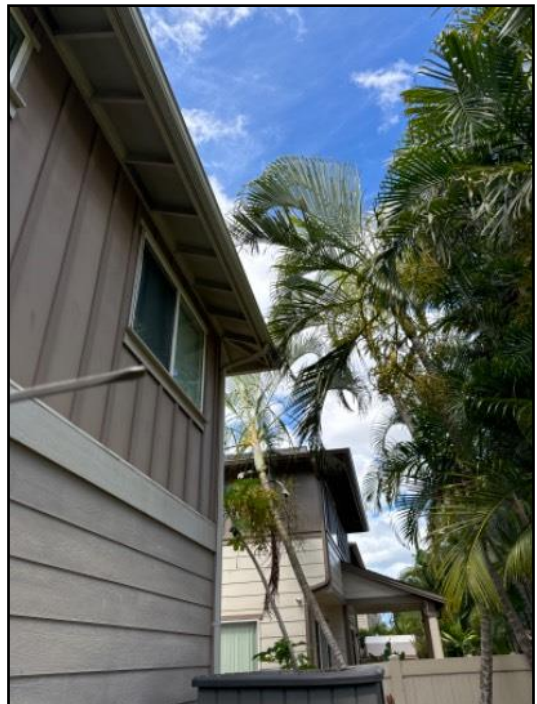
Would recommend trimming back vegetation and tree line back away from the house to prevent damage due to physical contact, wood rot and pest intrusion. Roof damage was observed at rear roofline and front porch.

*Trees or shrubs too close to building*

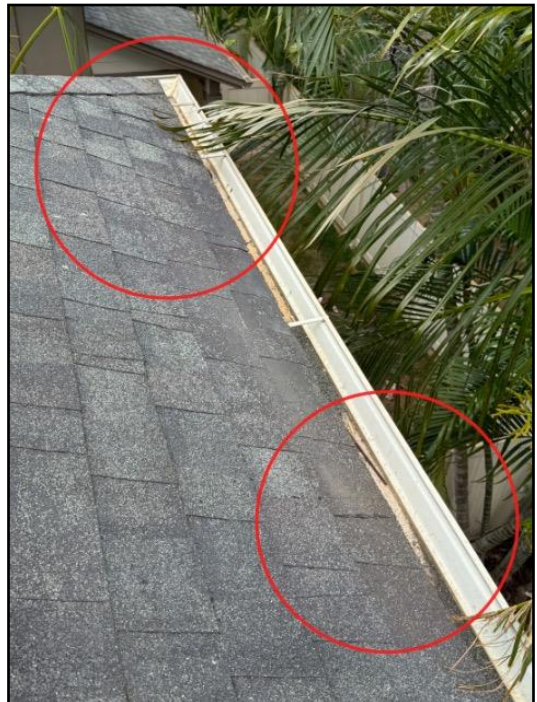
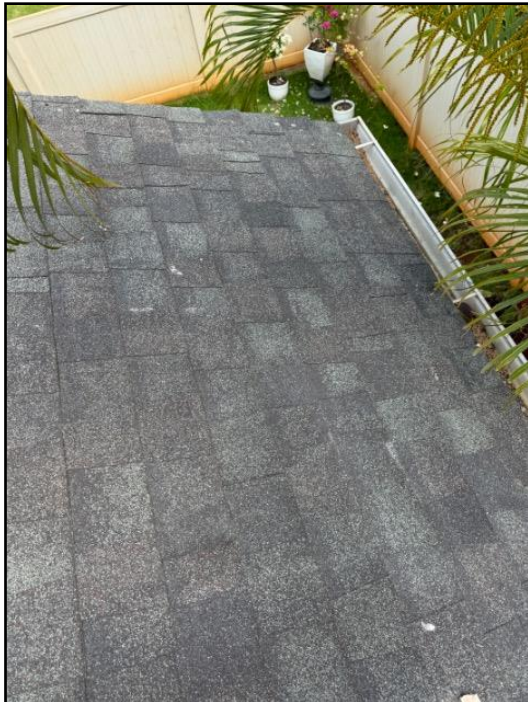
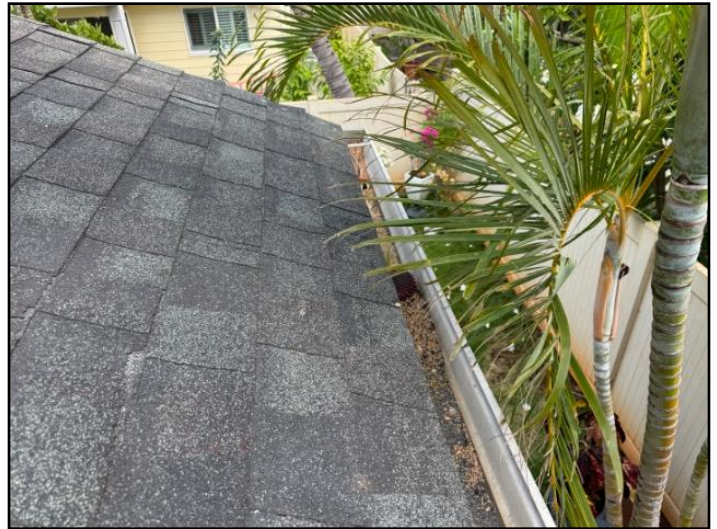
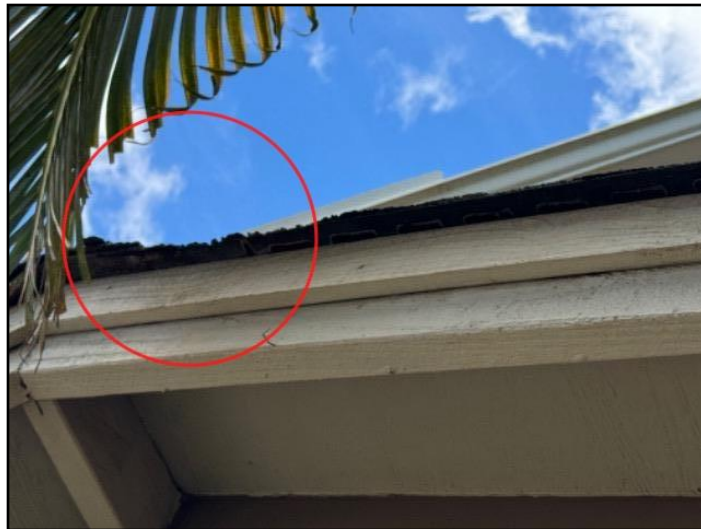
*Roof damage*

*Damage*

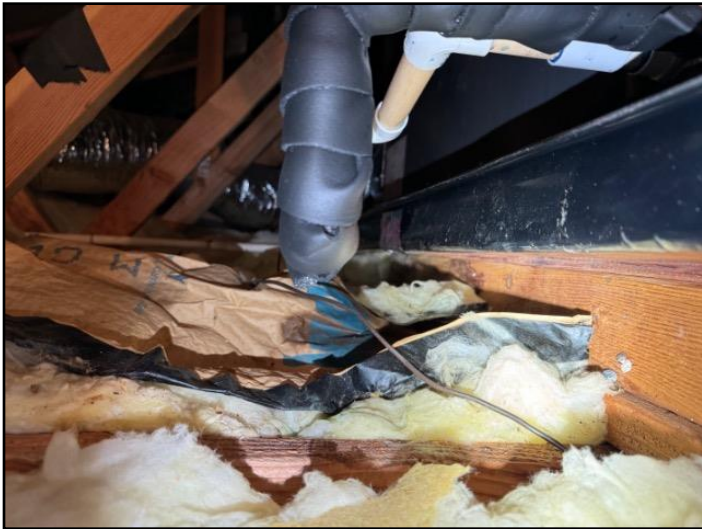
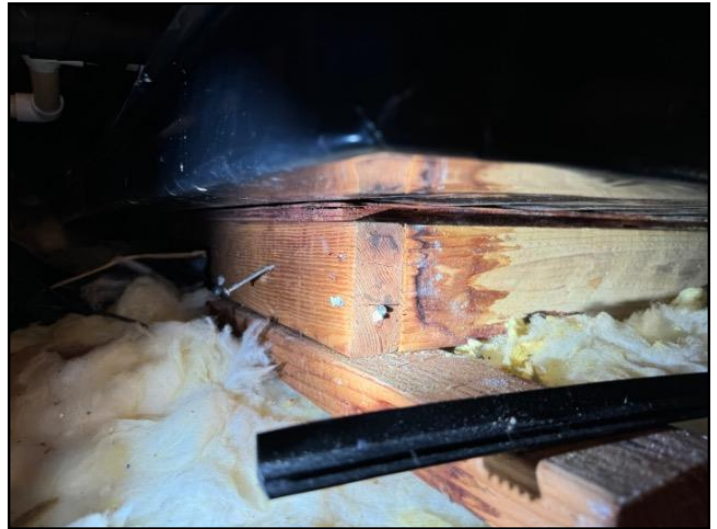
**Implication(s):** Water staining was observed at trusses below AC secondary drain pan. No active leaks observed. Recommend monitoring and seeking disclosure from seller regarding prior issues and repairs.

*Water stains*

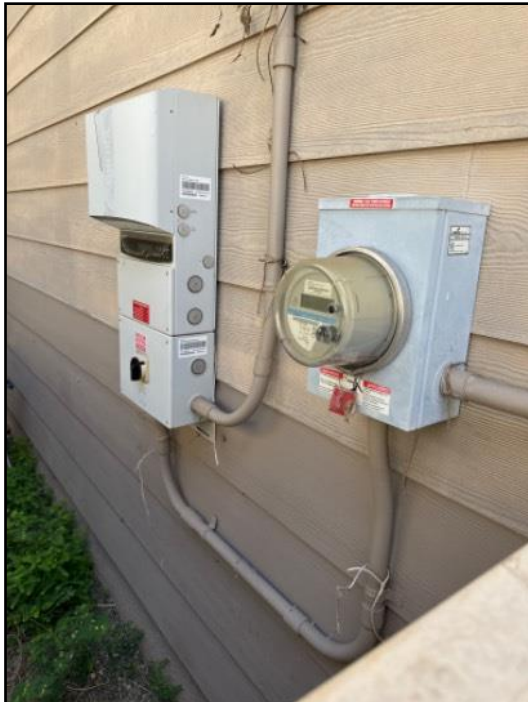
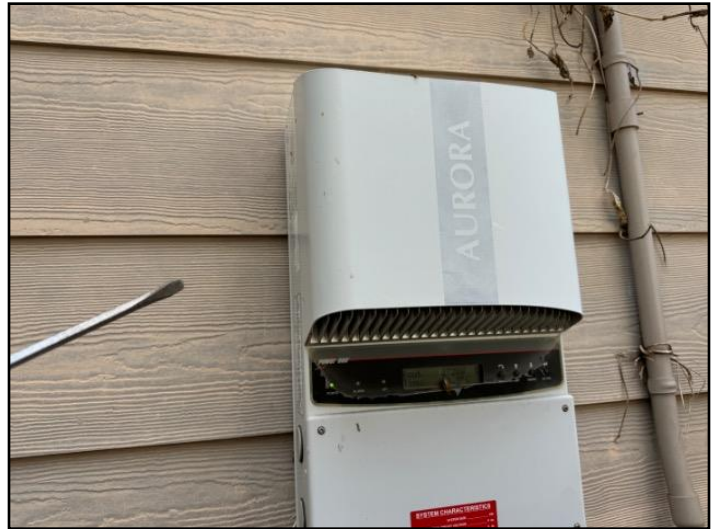
Would recommend cleaning panels. A buzzing was also observed from PV monitoring unit. Recommend service to ensure adequate performance.

*Solar panel meter/monitor*

Buzzing at monitor

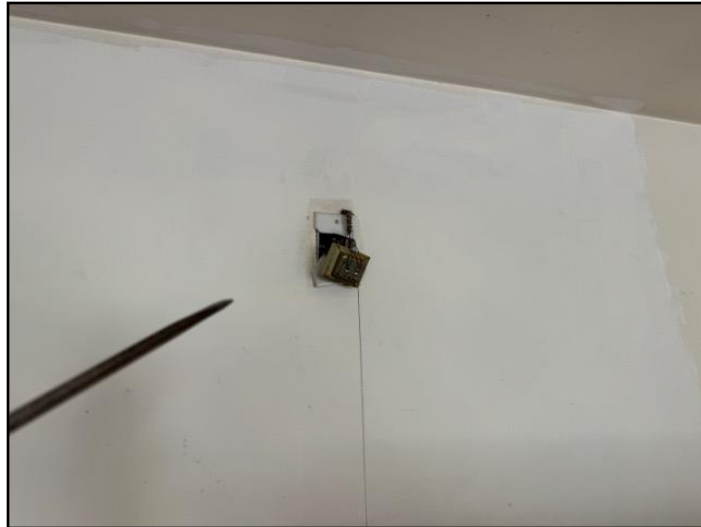
**Implication(s):** Garage mounted doorbell transformer was observed to be loose at wall above distribution panel.

*Loose transformer*

Recommend improvement to avoid damage to unit or injury.

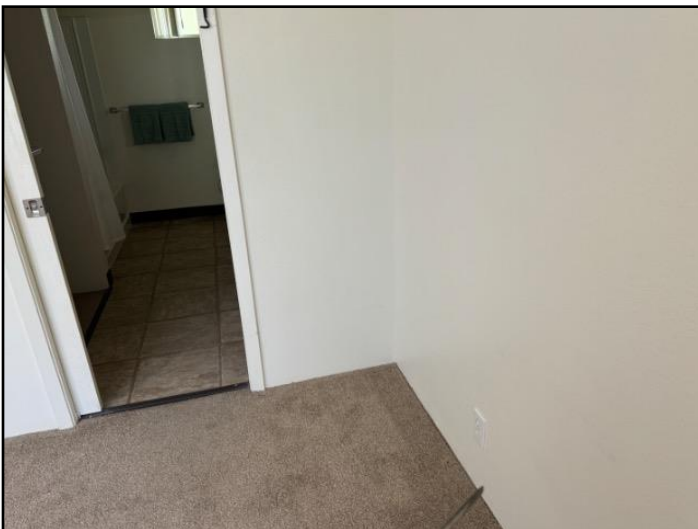
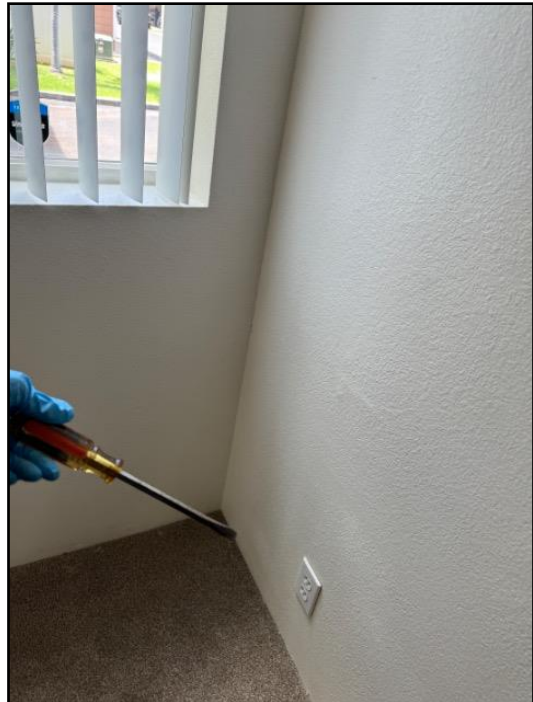
Several receptacles were observed to be loose and in need of tightening/repair.

*Loose @master*

*Loose @ lower stair landing*

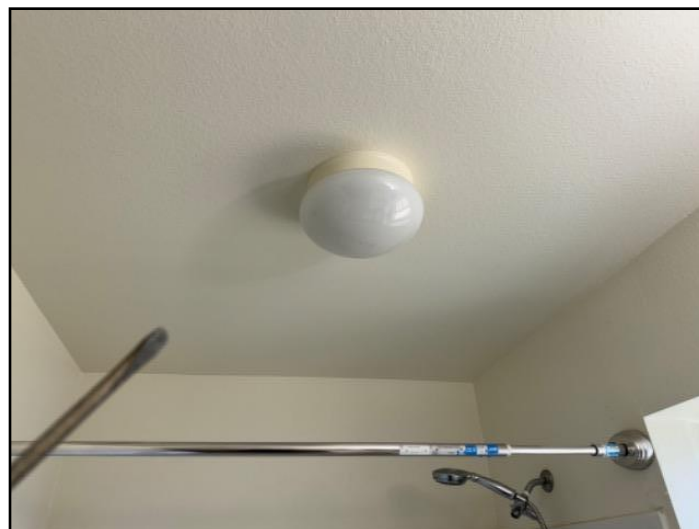
2nd floor guest bathroom ceiling light was inoperative. Recommend repair/replacement.

*Inoperative @ guest bathroom*

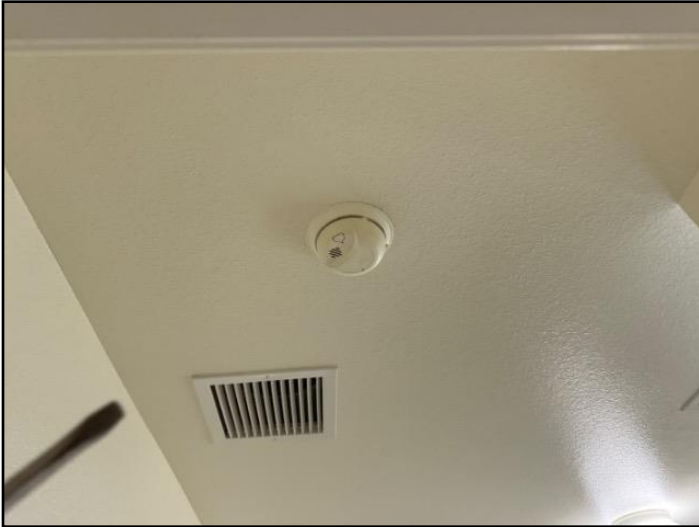
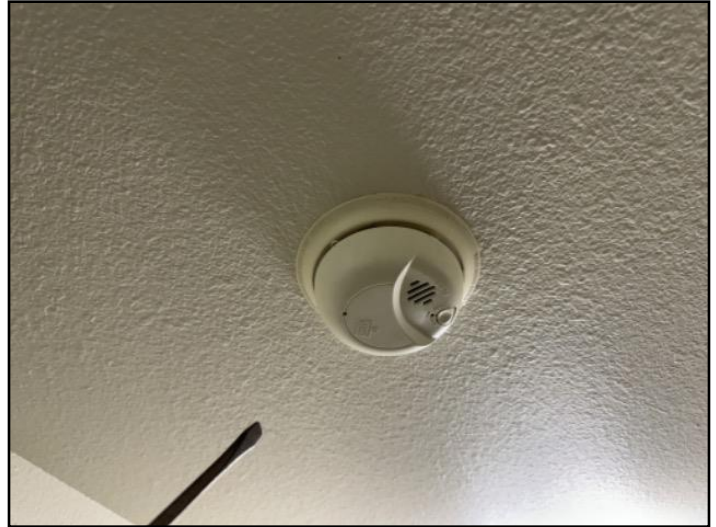
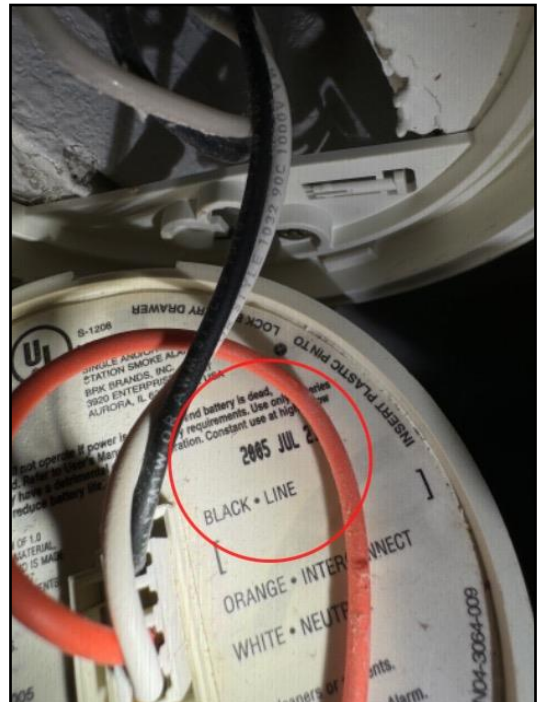
Existing smoke detectors were original units, yellowed and past their life expectancy of 10 years and in need of replacement for increased safety.

More than 10 years old

2005 Mfg year

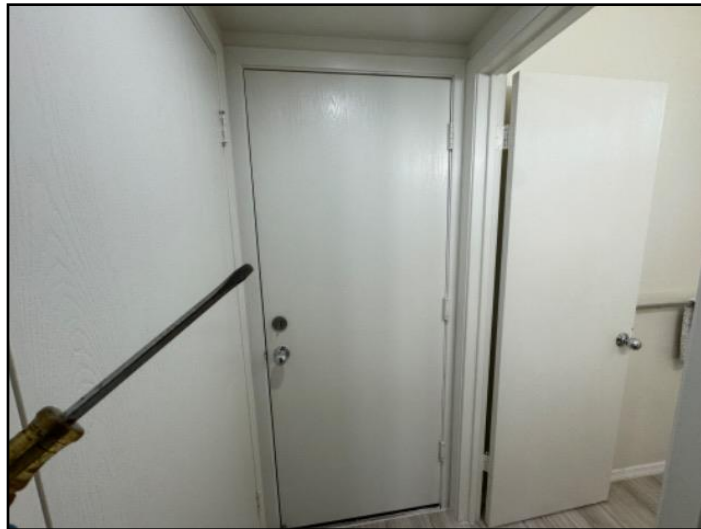
Due to adjoining garage and door into home, would recommend installation of carbon monoxide detectors for increased

*None observed*

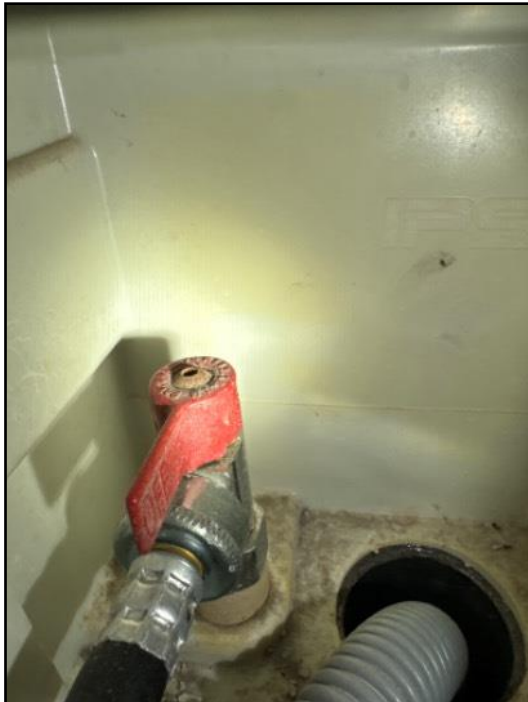
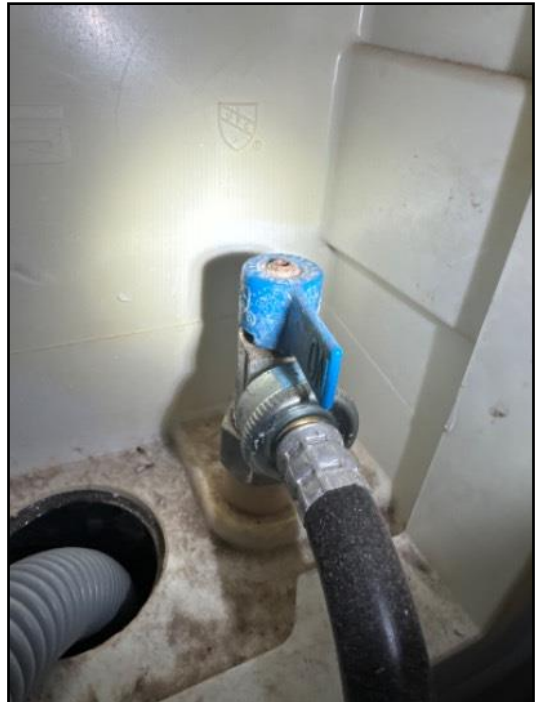
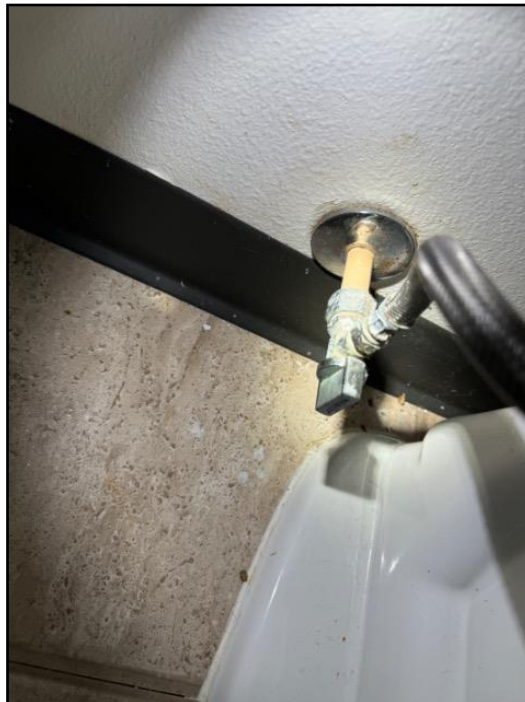
Corrosion was observed at laundry shut offs and some bathroom units as well. May be desirable to replace as a preventative measure. Units were not operated and no leaks observed.

*Rust*

*Corrosion*

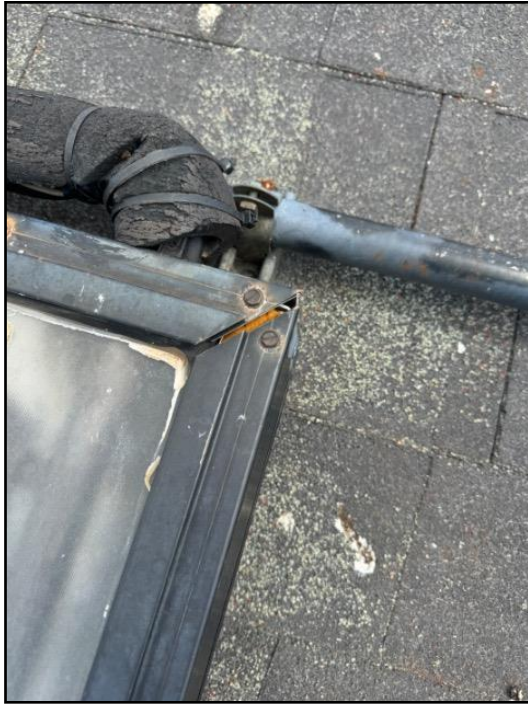
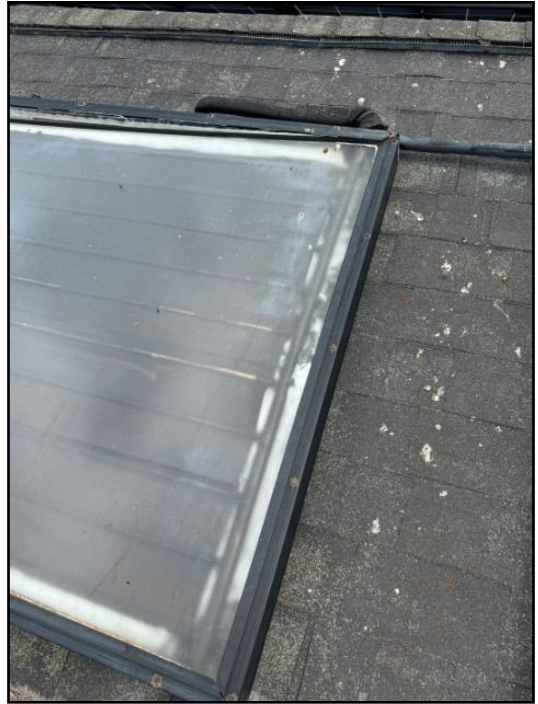
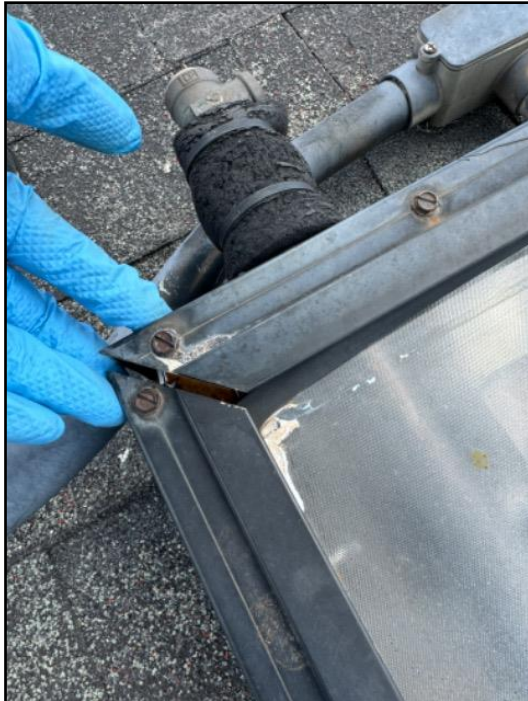
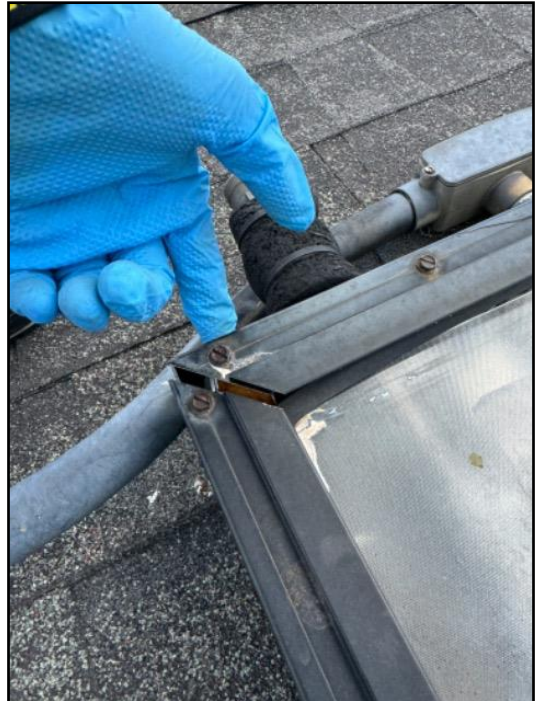
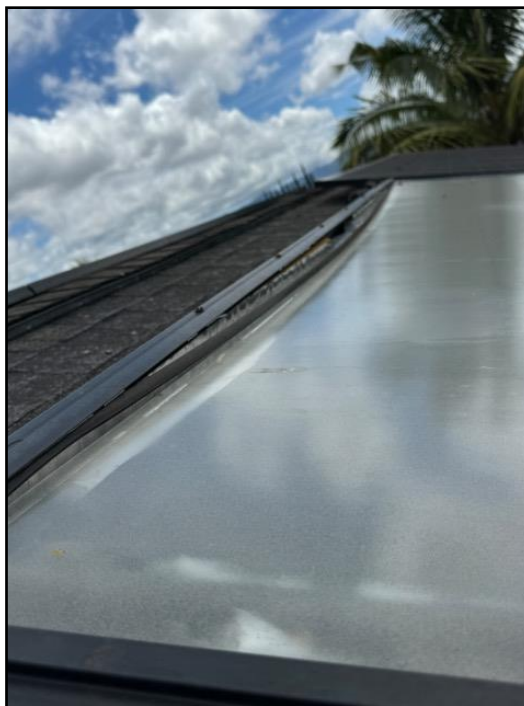
**Implication(s):** Solar water heater collector was damaged with visible frame separation and loose glass. Recommend immediate evaluation and repair/replacement for safety.

*Frame separation*

*Damage*

*Loose glass*

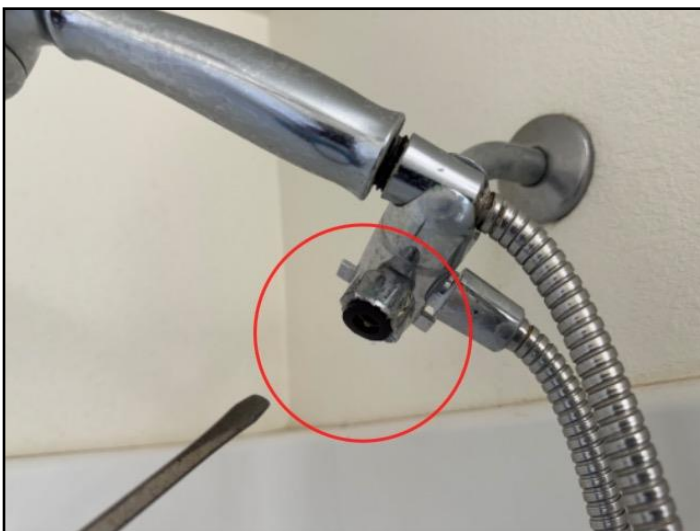
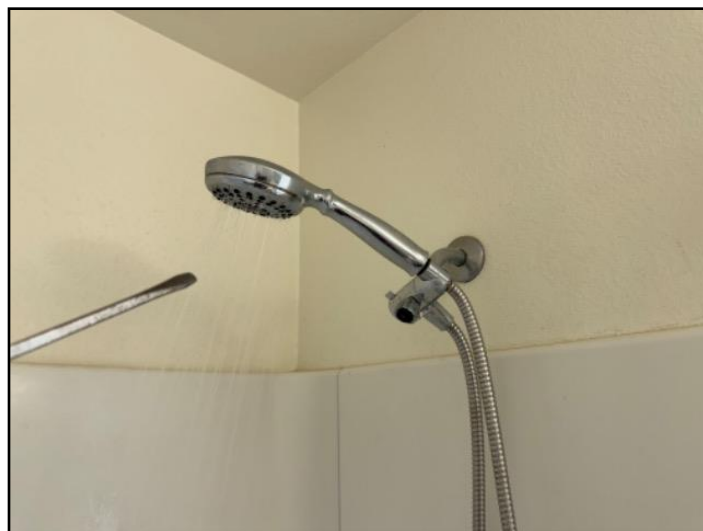
2nd floor hallway bathroom shower head was damaged. Recommend replacement. Existing upper unit was functional.

*Shower head damaged*

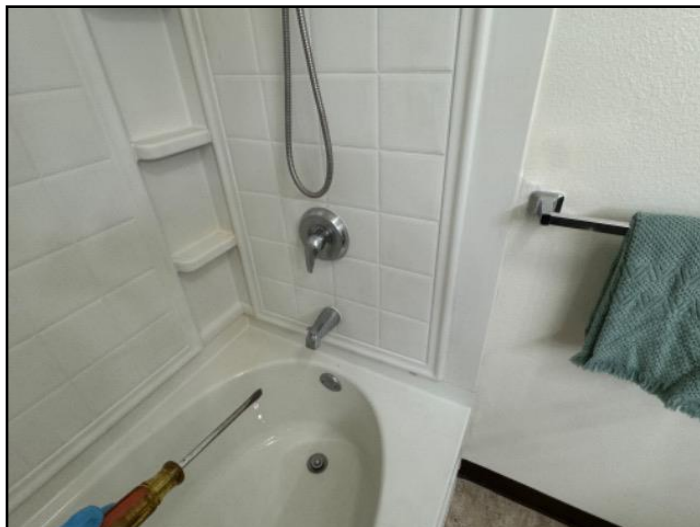
**Implication(s):** Master bathroom tub faucet was observed to only have hot water. Recommend further evaluation

and repair/replacement to avoid a potential scalding hazard.

*No cold water*

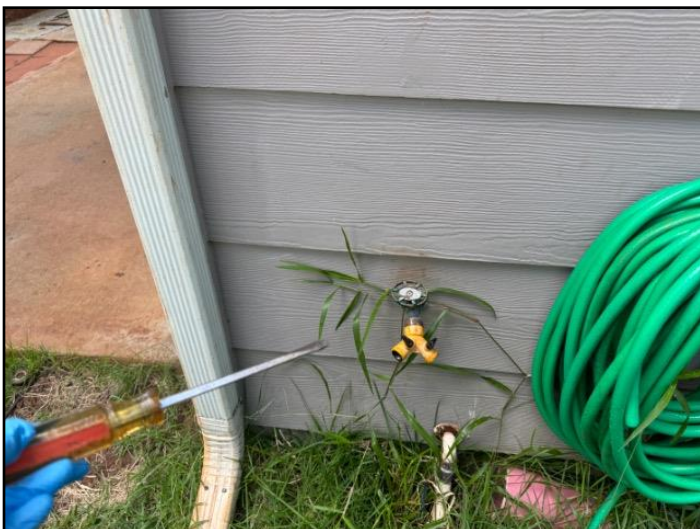
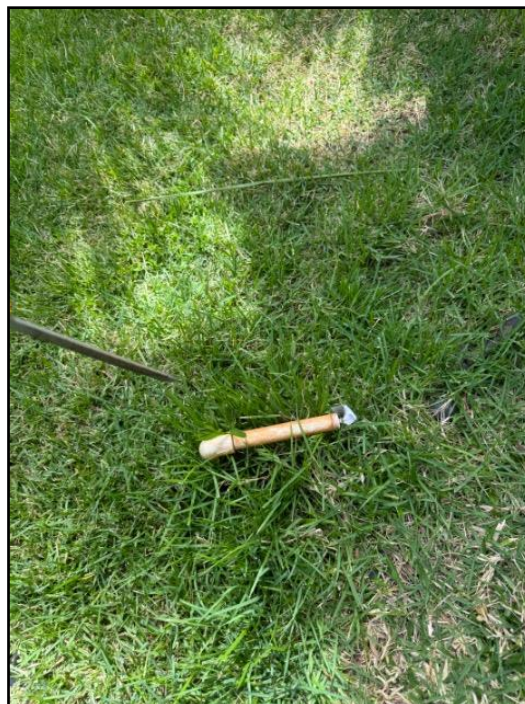
**Implication(s):** Hose bibbs at rear of house and front left corner were seized or dripping. Recommend repair/replacement to avoid waste or damage. Rear yard irrigation line was observed to be damaged. recommend repair if functionality desired.

*Seized hose bib*

*Damaged irrigation line*

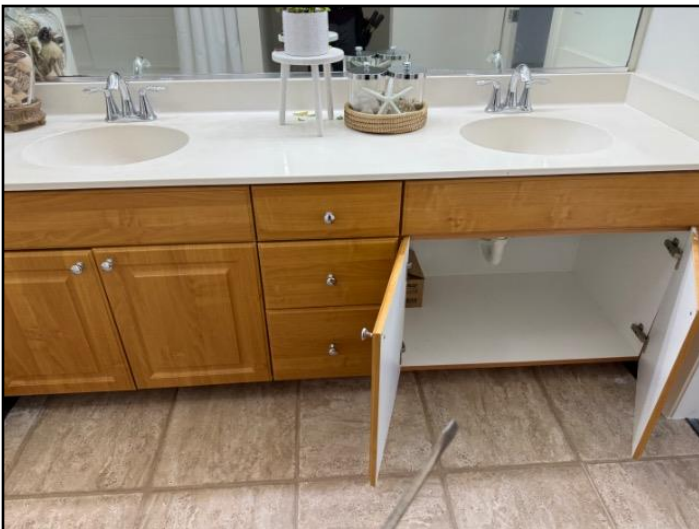
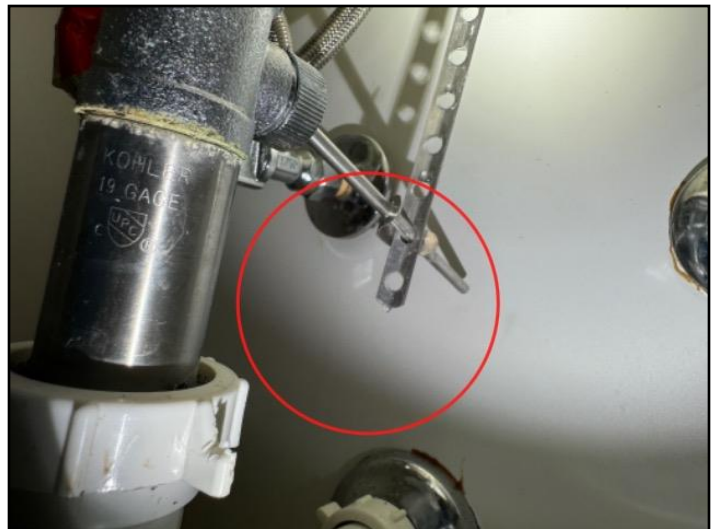
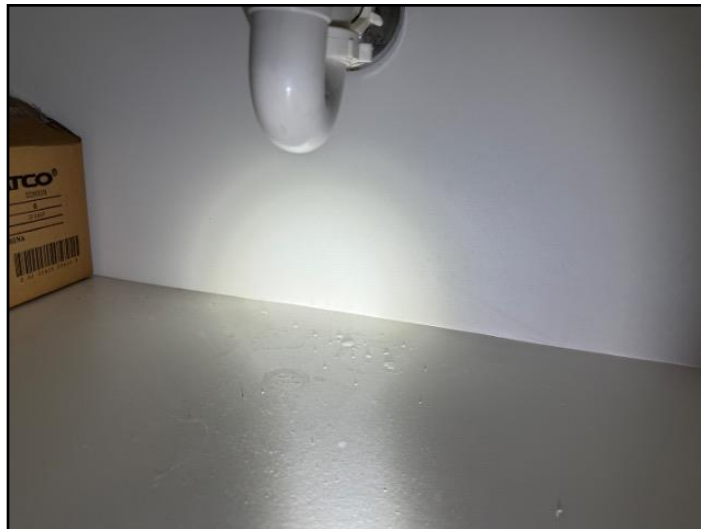
An active leak was observed at master bathroom right side sink drain stop linkage. Recommend immediate repair to avoid damage.

*Leak @right side vanity sink*

*Leak*

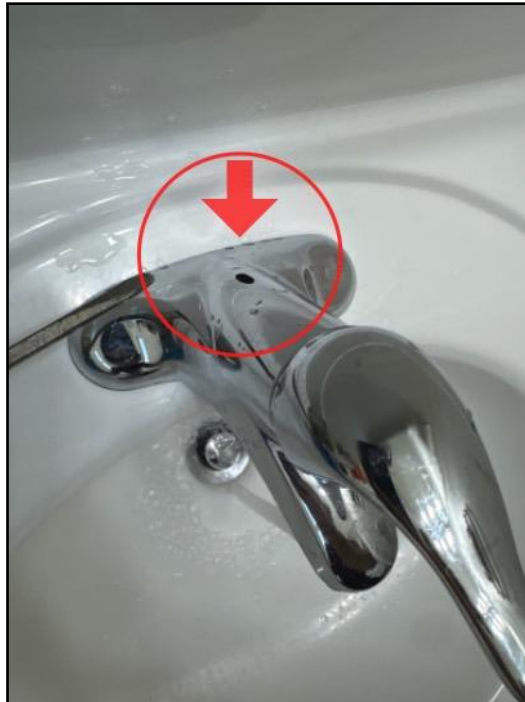
First floor bathroom vanity drain stop was disconnected and pull was missing thus rendering it inoperative. Recommend improvement.

*Drain stop missing*

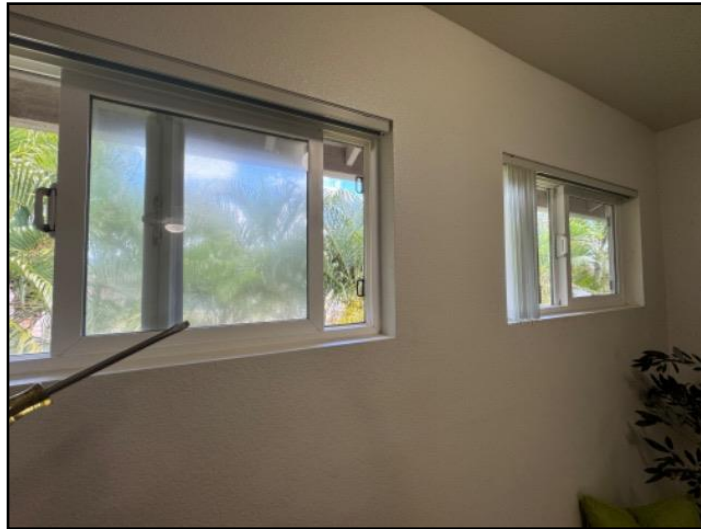
Left window at 2nd floor stair landing was observed to have lost its internal seal and was hazed over. Recommend repair/replacement.

*Lost seal on double glazing*

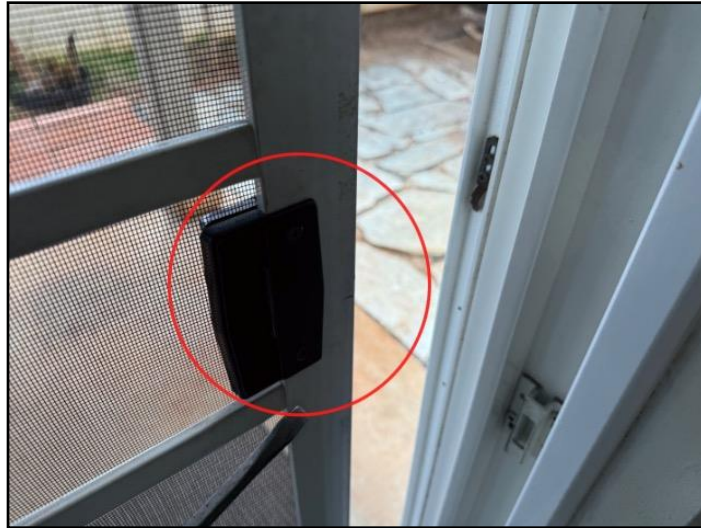
Dining room sliding screen door latch was missing. Recommend repair/replacement to restore functionality.

*Missing latch*

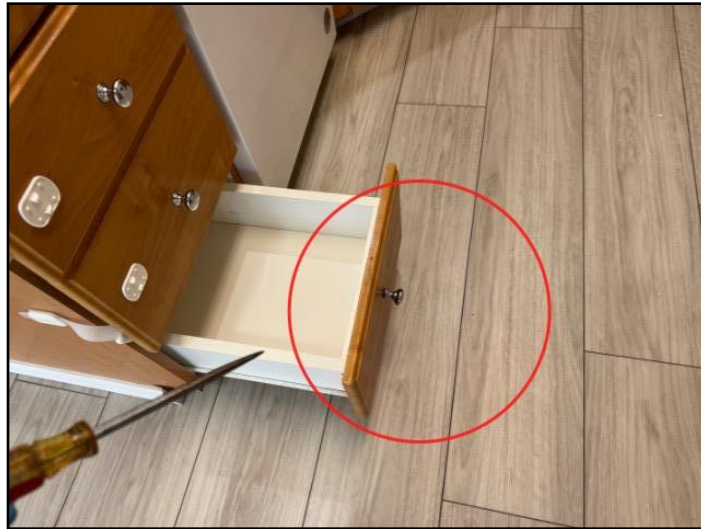
**Implication(s):** Left lower drawer pull was loose and is need of repair. Recommend repair/replacement.

Loose hardware

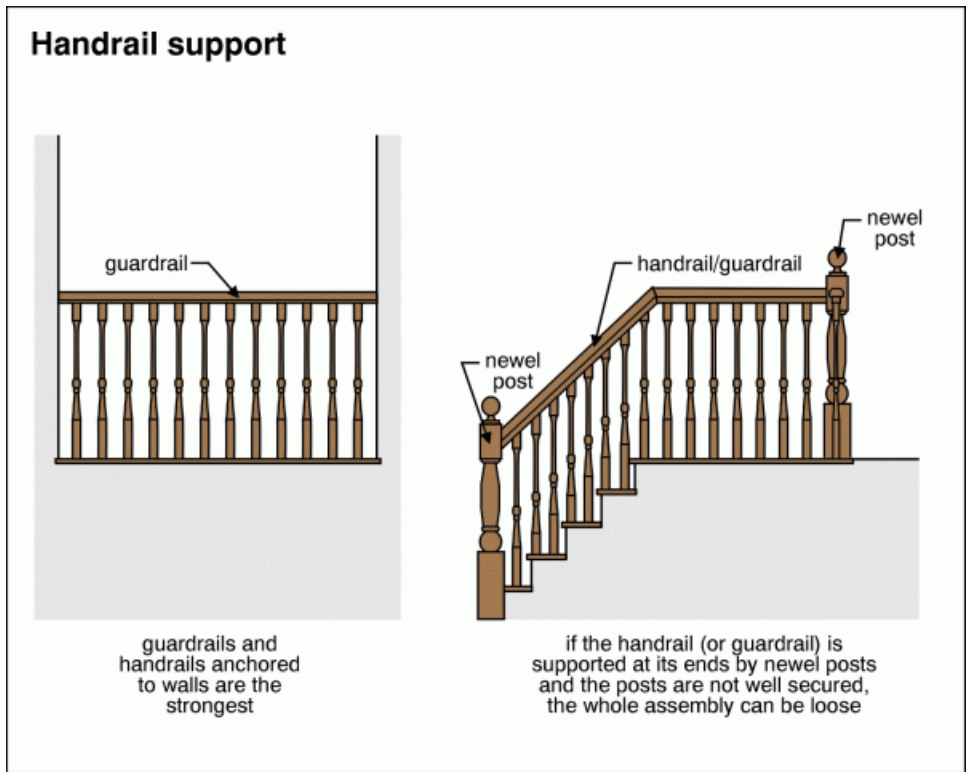
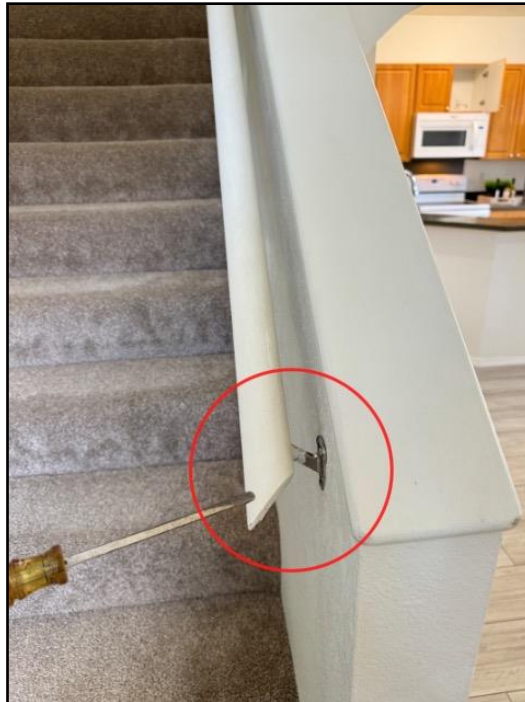
Lower handrail hardware was loose. Recommend repair for safety.

*Loose*

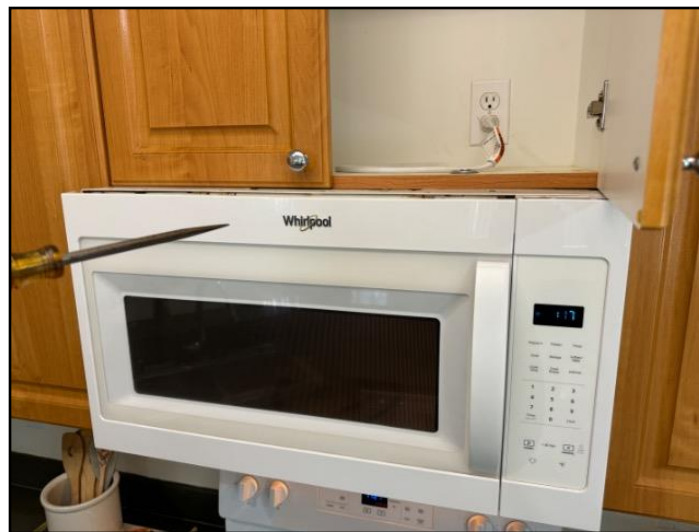
Existing venting arrangement was set to recirculate however an exterior duct to exterior was observed. Recommend improvement of arrangement.

*Not vented to exterior*
