# INSPECTION REPORT

**91-1143 KANELA STREET, M7**  
EWA BEACH, HI 96706

Prepared for: SOPHIA THOMPSON  
Inspection Date: Monday, July 29, 2024  
Prepared by: Steven Fierros

RE: Report No. 1118  
91-1143 Kanela Street, M7  
Ewa Beach, HI  
96706

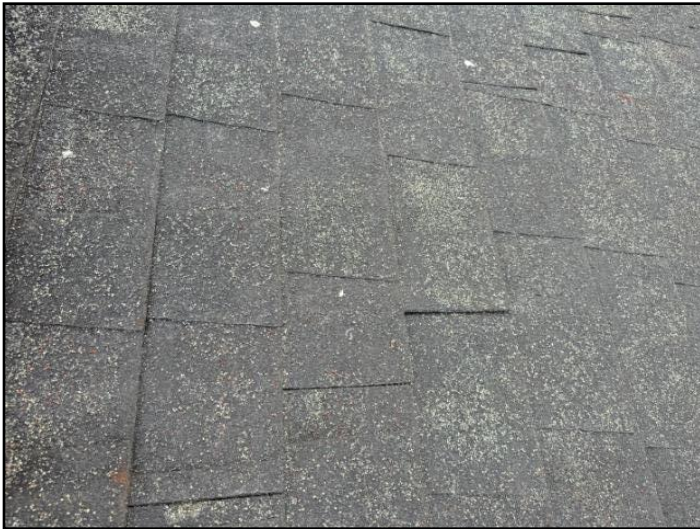
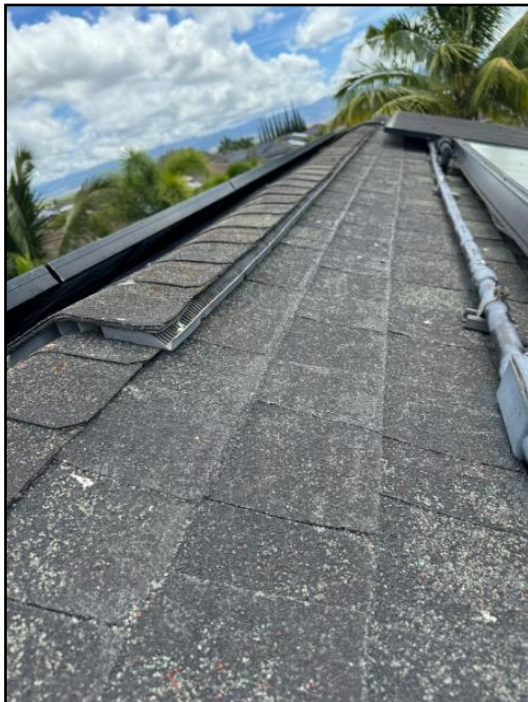
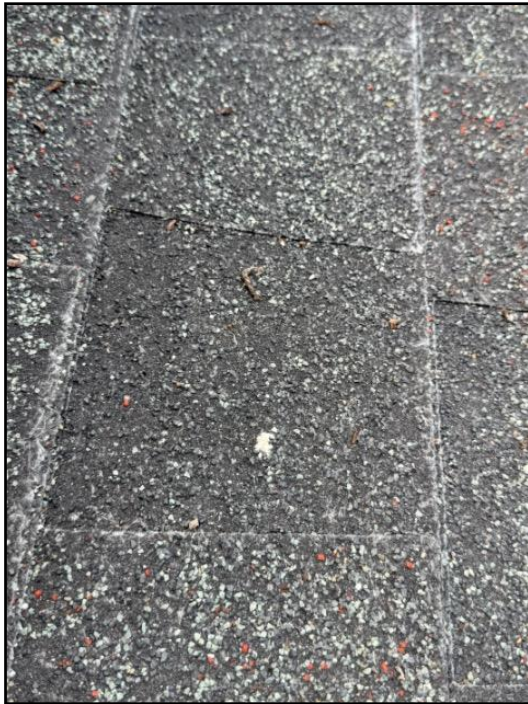
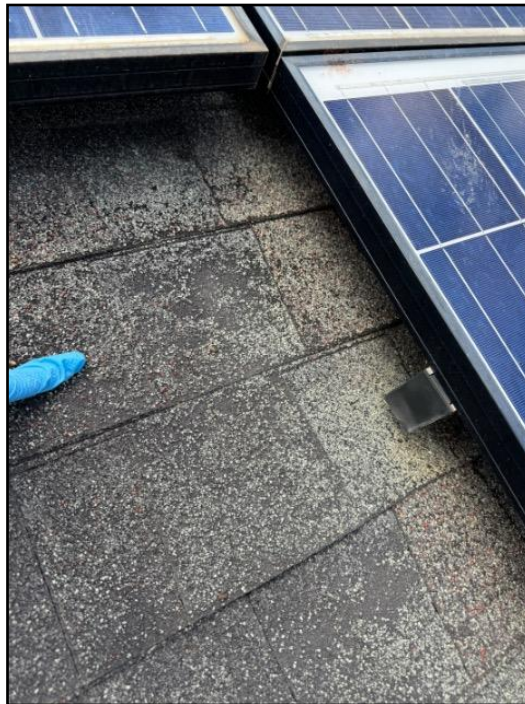
Heavy granule loss was observed at street facing roof plane. Various birds and bird presence was observed at this area and below PV panels. Recommend further evaluation and repair/replacement by a qualified roofing contractor. Would also recommend protection of under panels to prevent future pest presence/issues.

*Granule loss*

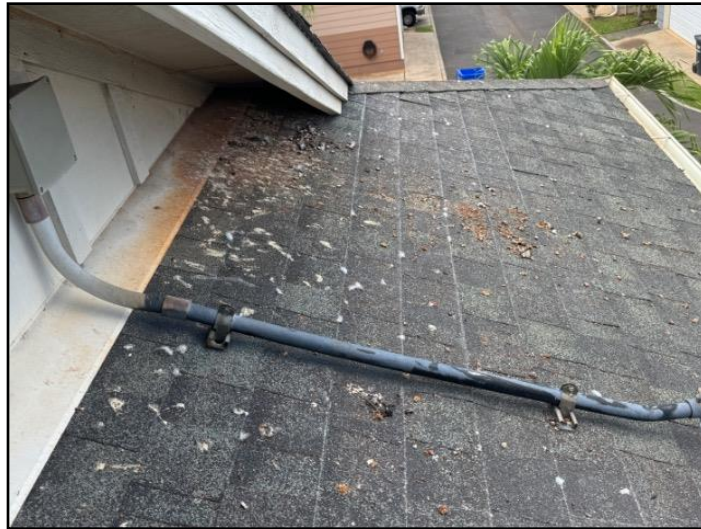
**Implication(s):** Active pest presence(birds) was observed on roof and under PV panels. Recommend cleaning/improving.

*Pest presence/debris*

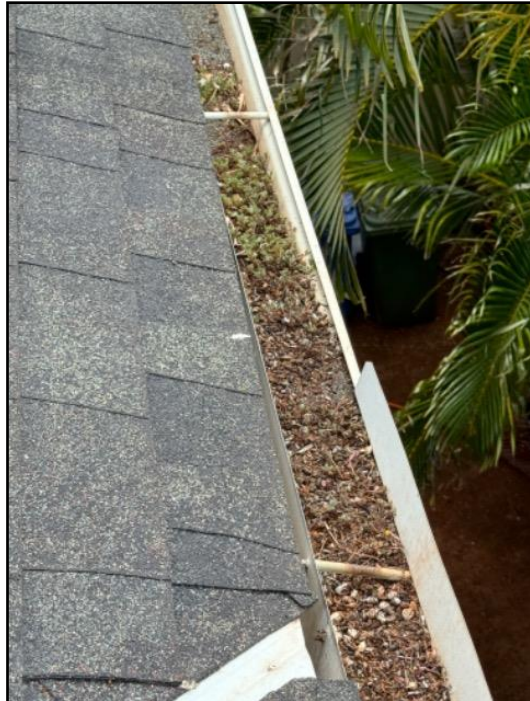
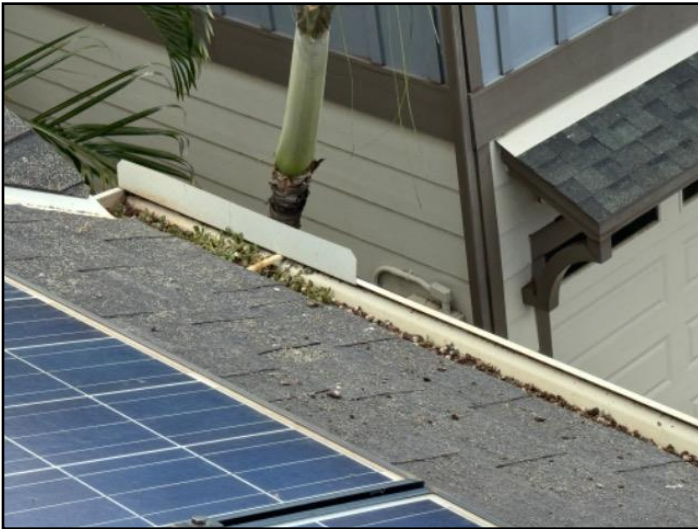
Would recommend cleaning gutters routinely to avoid poor drainage and ponding. Debris and rock loss was observed. Recommend cleaning.

*Dirty/debris*

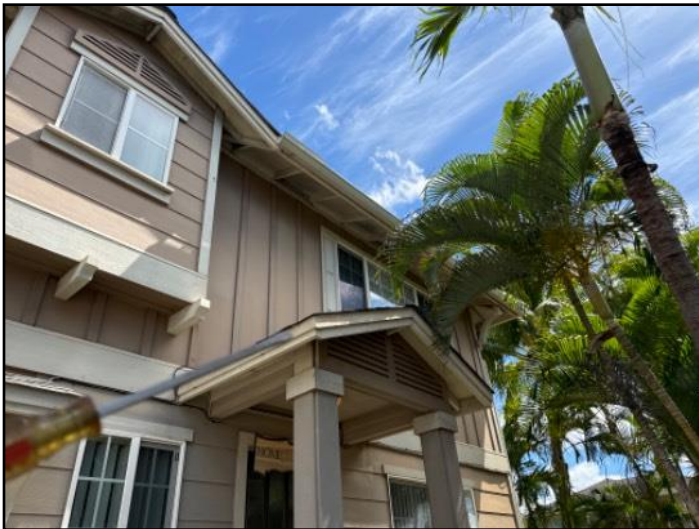
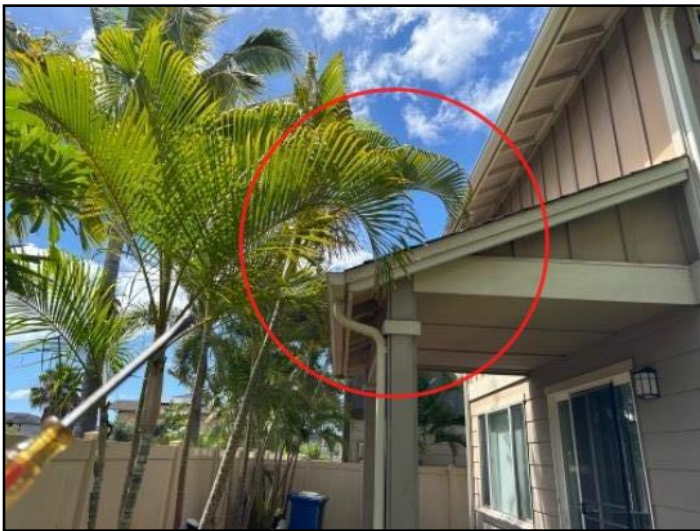
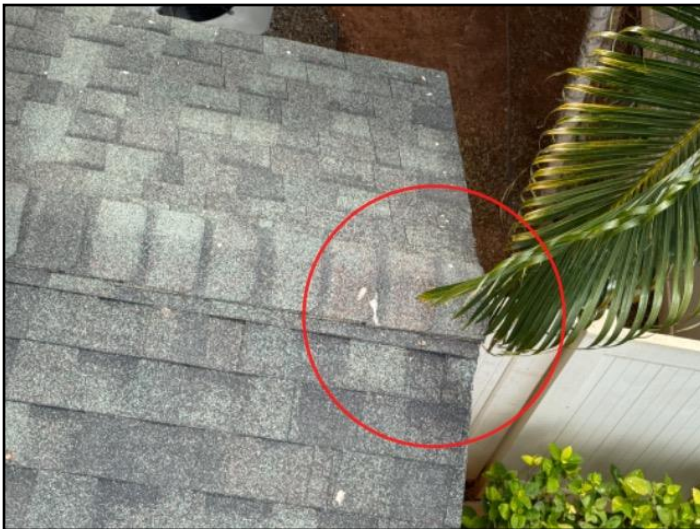
Would recommend trimming back vegetation and tree line back away from the house to prevent damage due to physical contact, wood rot and pest intrusion. Roof damage was observed at rear roofline and front porch.

*Trees or shrubs too close to building*

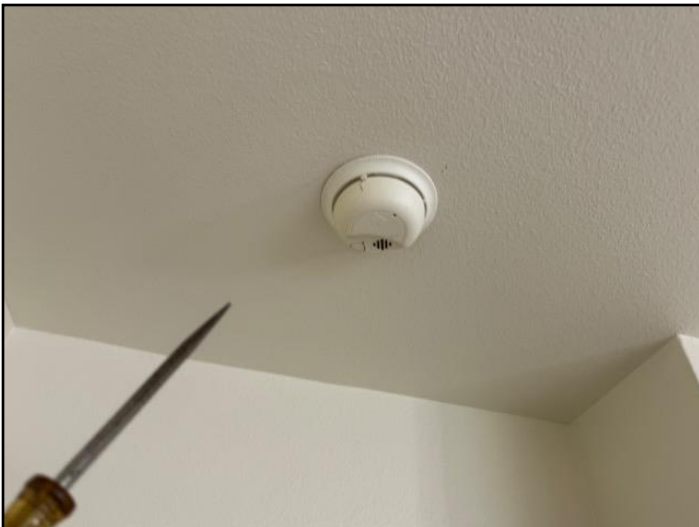
Existing smoke detectors were original units, yellowed and past their life expectancy of 10 years and in need of replacement for increased safety.

More than 10 years old
